Manhole Inspection Summary

Manhole # S27M__024MH

Insp Date: **5/5/08 12:43 PM**

Location Address: **1209 Ward St**

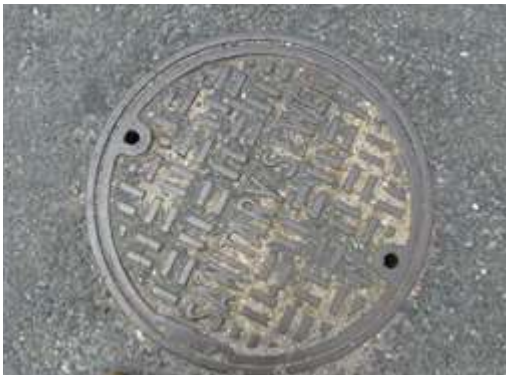
Cover View

Cover Shape: **Circular** Diameter: **26** (in.) Length: **0** (in.) Dist A/B Grade: **0** (in.)

Type: **Sanitary** Condition: **Sound** Cover Material: **Cast Iron**
